Manhole Inspection Summary

Manhole # S29EE2017MH

Insp Date: **12/4/06 10:27 AM**

Location Address: **6 GREENLEAF RD**

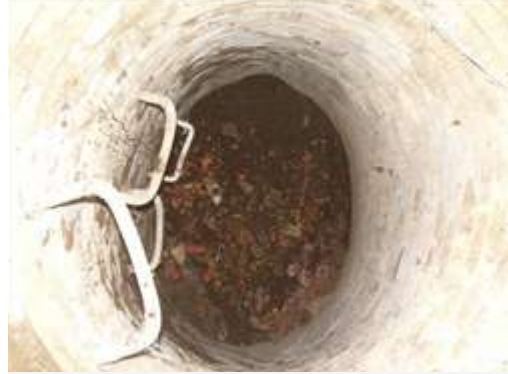
Top View

Channel debris.

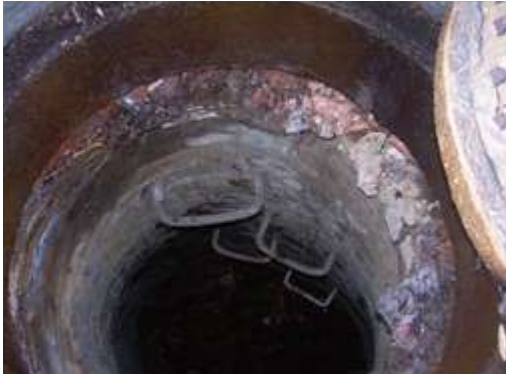
Defect

☒ **Leaks**

Condition: ☐ Sound ☐ Cracked ☐ Root Intrusion ☒ **Loose Brick** ☒ **Deteriorated**

Infiltration: ☐ None ☒ **Joint** ☐ Cracks ☒ **Mortar** ☐ Roots ☒ **Wall**

Frame leaks. Frame offset. Adjustment deterioration, loose bricks and infiltration.

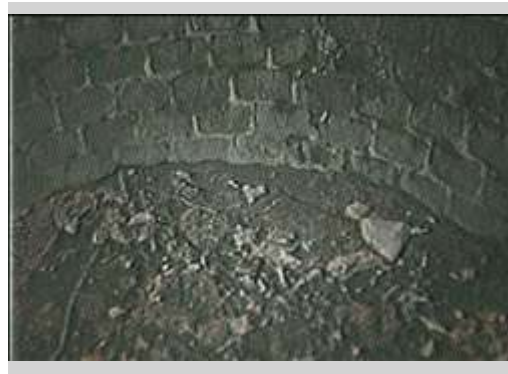
Defect

Barrel infiltration.

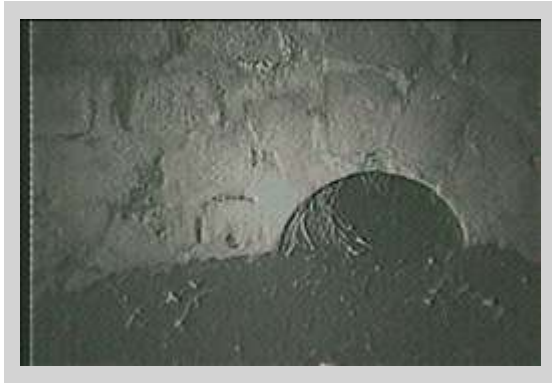
8 in. Circular Gravity Sewer
Pipe Out @ 12 O'Clock

Root intrusion inside of the pipe.
